PRELIMINARY REPORT

Serious incident

17-3-2016

ATR42 500

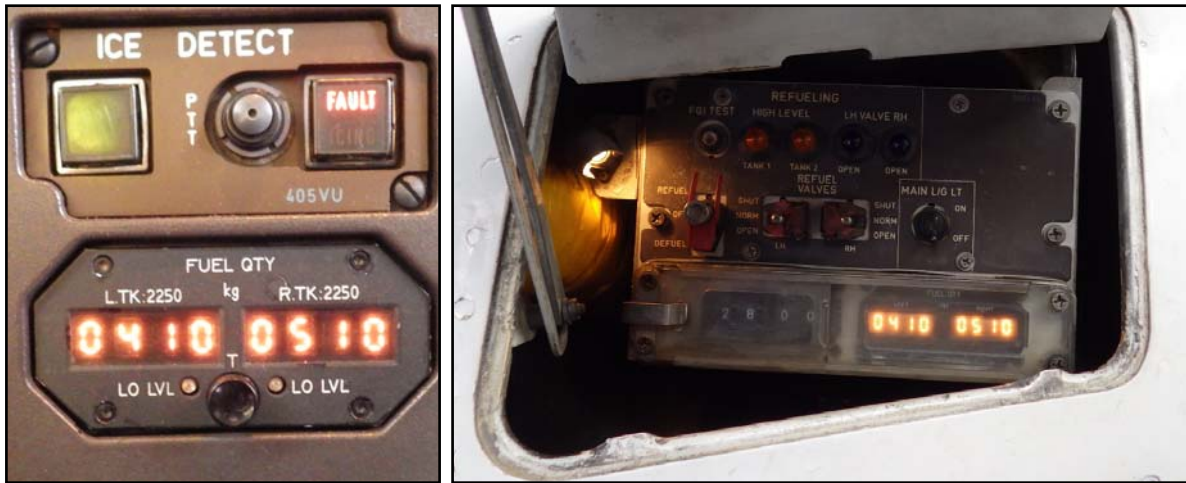
1. The right fuel tank was empty.
2. The fuel quantity indicator in the cockpit and the fuel quantity indicator repeater located at the refueling panel on the right side of the aircraft below the wing root indicated:
 - Left fuel tank 410 kg, which corresponded to the fuel amount in the tank.
 - Right fuel tank 510 kg, despite the fuel tank was empty.
 - Right fuel tank low level light (LO LVL) did not illuminate on the fuel quantity indicator, despite the fuel level was below 160 kg.

The fuel quantity indicator and the repeater were replaced with new units. The new indicators indicated the same values as presented above. The original indicators were reinstalled.

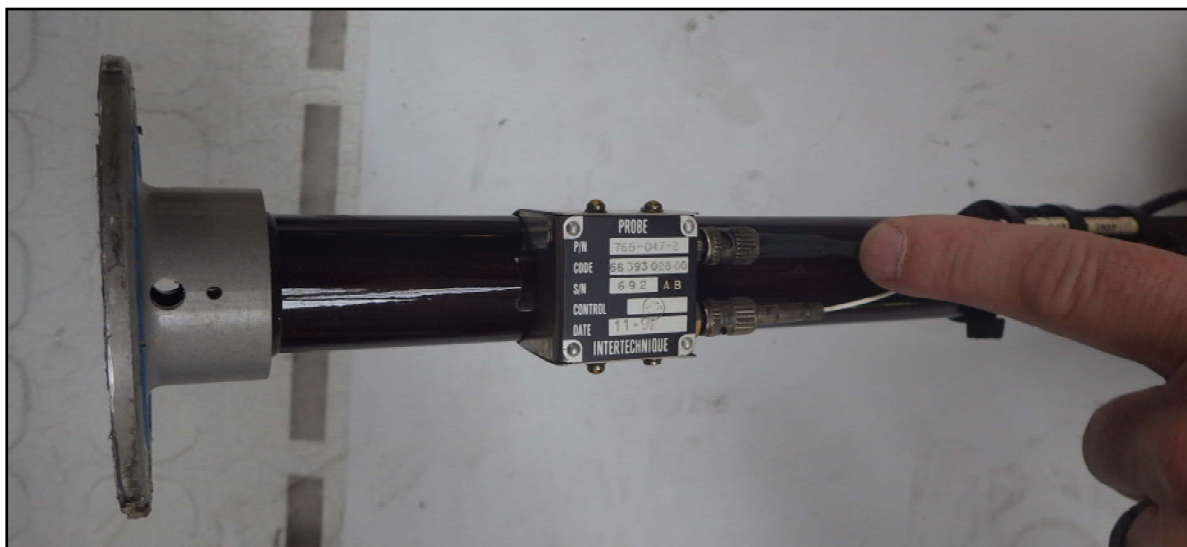
Probe No 3 PF value was significantly out of limit.

The values of probe No 3 changed when the brown wire (covered by heat-shrinkable tubing) was manipulated close to the connector (pointed out in the picture below).

The values changed between the first test value measured 40.2 PF to 44.6 PF and 47.5 PF.

The preliminary AIB investigation revealed that the fuel quantity indication failure was related to the right tank probe No 3 and / or the associated wiring.

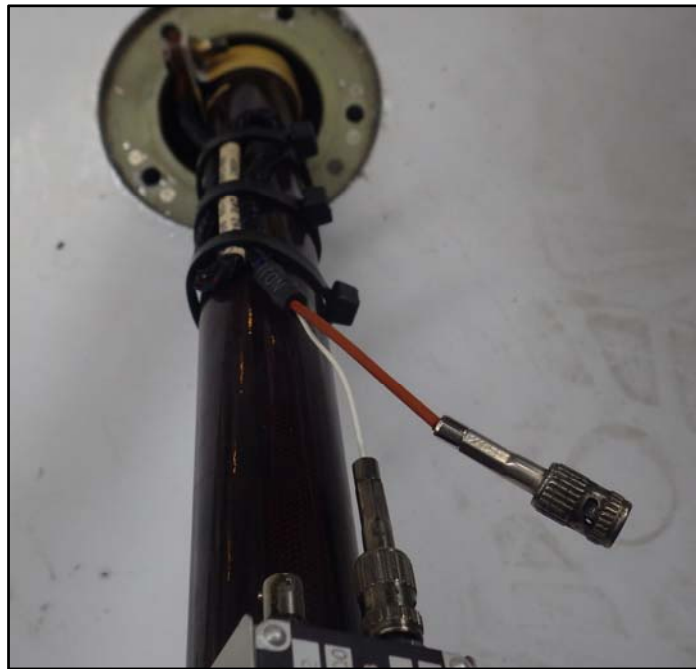
The brown wire was in connection with the connector as shown in the picture below.

When further manipulated, the PF value turned back to the normal value of 36.7 PF, which was a value within limit.

Thereafter, it was not possible to recreate the fault value(s) by moving the wire and/or the connector.
